Re: Maintenance Plan for Cap Proposed in *Remedial Action Plan*  
Former Florida Smelting Company/Bufalo Avenue  
5800 Buffalo Avenue  
Jacksonville, Florida  
DEP Site # Com\_293274, DEP Project #315913  
1739-00

### **PROPOSED LONG-TERM MAINTENANCE AND MONITORING PLAN**

## Management Area

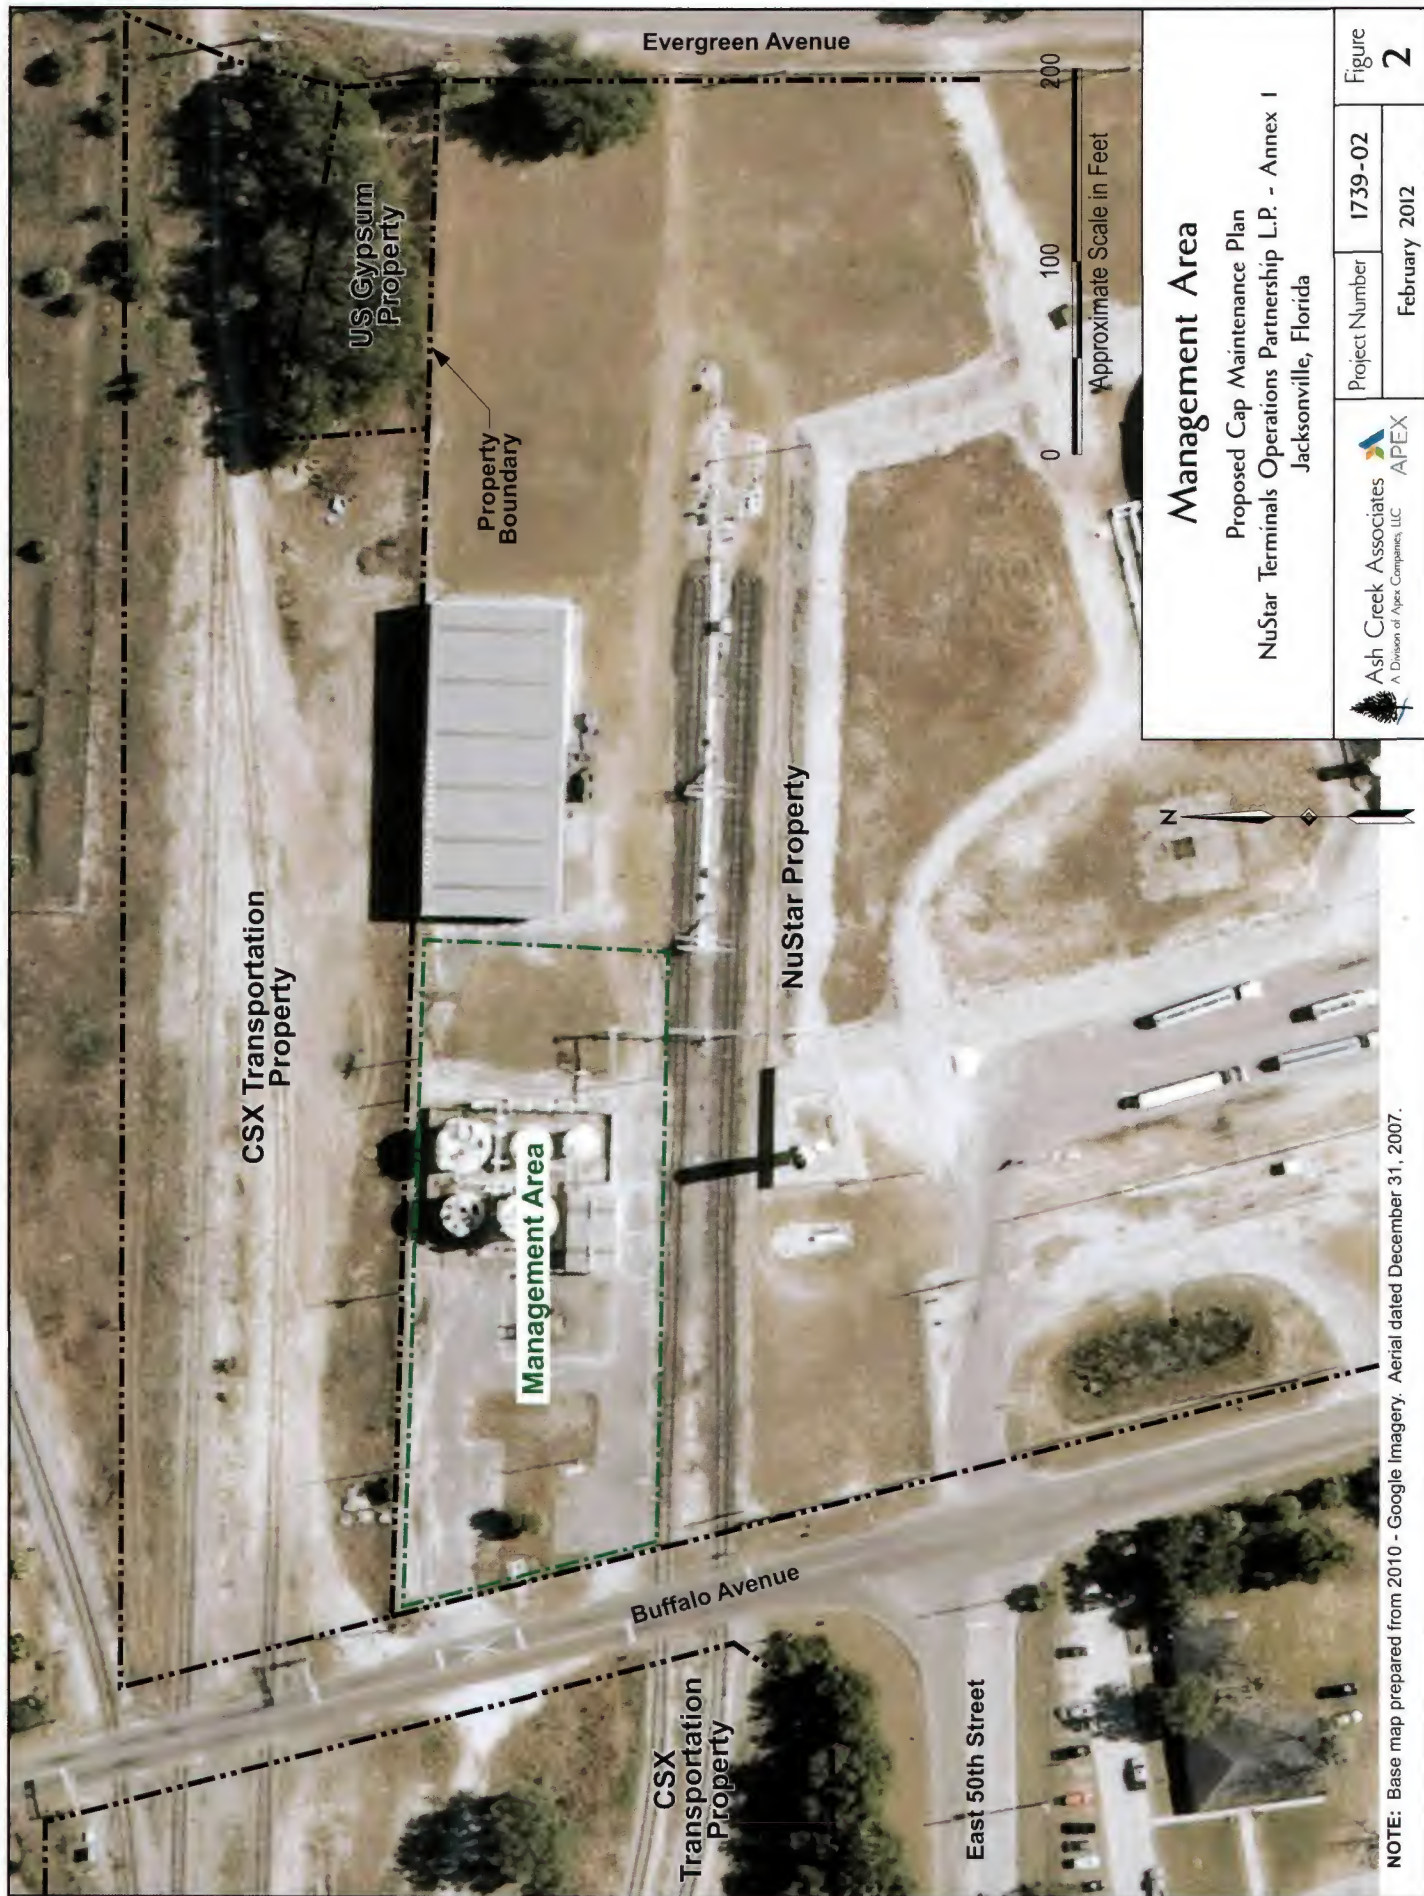
Figure 2

NOTE: Base map prepared from 2010 - Google Imagery. Aerial dated December 31, 2007.

This letter provides a long-term monitoring and maintenance plan for the asphalt cap proposed in a *Remedial Action Plan*, submitted to the Florida Department of Environmental Protection (FDEP) on December 29, 2011 for the northern portion of the NuStar Terminals Operating Partnership L.P. (NuStar) Jacksonville Annex I bulk fuel terminal, referred to herein as the Investigation Area. The Terminal is located at 5800 Buffalo Avenue in Jacksonville Florida (Figure 1). The Investigation Area is shown on Figure 2.

A Remedial Action Plan (RAP) was submitted to FDEP on December 29, 2011, which proposed installation of an asphalt cap to address soil in the area containing lead above soil cleanup target levels (Management Area), preparation of a contaminated media management plan (CMMP), institutional controls in the form of a restrictive covenant, and two additional groundwater monitoring events for well ACA-1 (Ash Creek, 2011b). A small portion of the Management Area inside of the tank farm secondary containment was not included in the proposed asphalt cap area because: (1) extensive aboveground piping networks and containment structures severely limit mobility in that area, preventing access for construction equipment; (2) most of the ground surface in the containment area is currently covered with gravel, minimizing the potential for direct contact with soil; (3) workers rarely enter the containment area since the tanks are inactive and do not require routine operations and maintenance activities. FDEP requested in a January 26, 2012 e-mail to NuStar that a Florida professional engineer approve the recommendation in the RAP that the tank farm secondary containment is an acceptable barrier for human exposure. This letter serves as an approval of the recommendations detailed in the RAP.
